Manhole Inspection Summary

Manhole # S15G1_002MH

Location Address: **3101 Washington Blvd.**

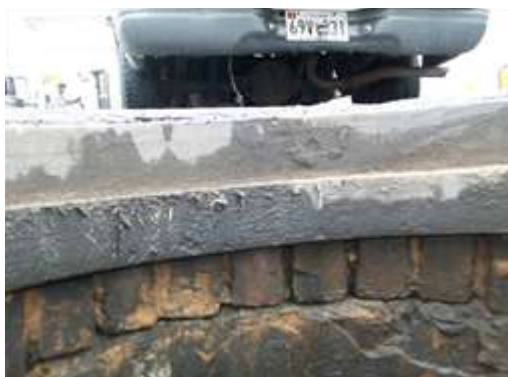
Defect 2

Frame Offset: **0** (in.) Condition: ☐ Sound ☐ Cracked ☒ **Leaks**

frame leaks

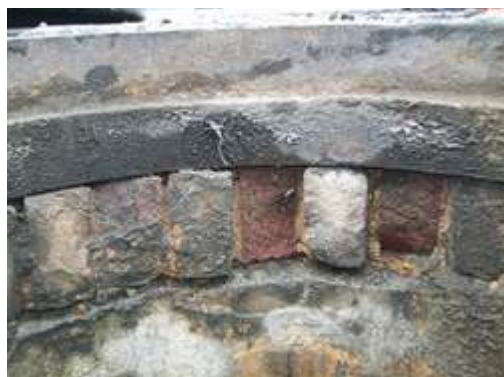
Defect 1

Condition: ☐ Sound ☐ Cracked ☐ Root Intrusion ☒ **Loose Brick** ☐ Deteriorated

loose/missing bricks

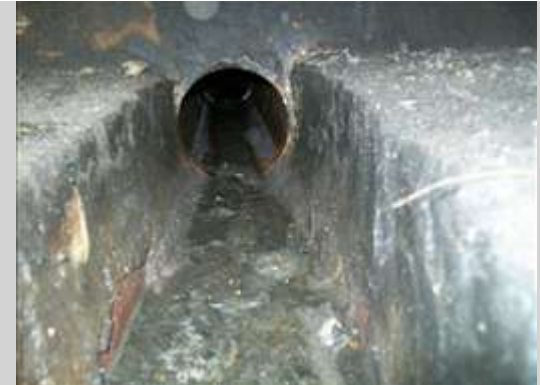
12 O'Clock Outflow

Pipe Height: **6** (in.) Rod and Bar (Angled)
Pipe Material: **Clay** ☐ Pipe Lined
Invert Depth: **5.67** (ft.) Flow Characteristics: **Slow**
Deposits: ☐ None ☐ Mud ☒ **Sludge** ☐ **Debris** ☐ Grease
Silt Depth: **2** (in.) Deposits Extent: **Light**
Infiltration: **None** Pipe Seal Cond: **Sound**

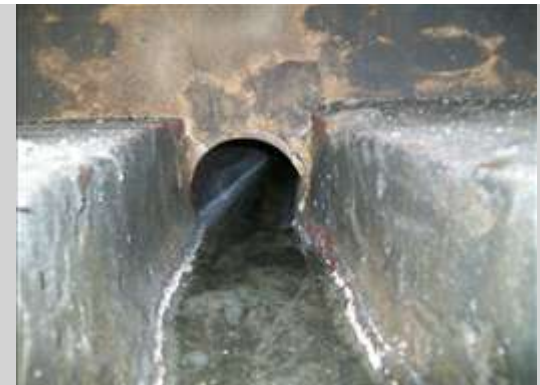
6 O'Clock Inflow

Pipe Height: **6** (in.) Rod and Bar (Angled)
Pipe Material: **Clay** ☐ Pipe Lined
Invert Depth: **5.61** (ft.) Flow Characteristics: **Slow**
Deposits: ☐ None ☐ Mud ☐ Sludge ☒ **Debris** ☐ Grease
Silt Depth: **1** (in.) Deposits Extent: **Light**
Infiltration: **None** Pipe Seal Cond: **Sound**
